Sustainable Development of Civil, Urban and Transportation Engineering Conference

Thickness of Corrosion Layers on Typical Surfaces of Weathering Steel Bridges

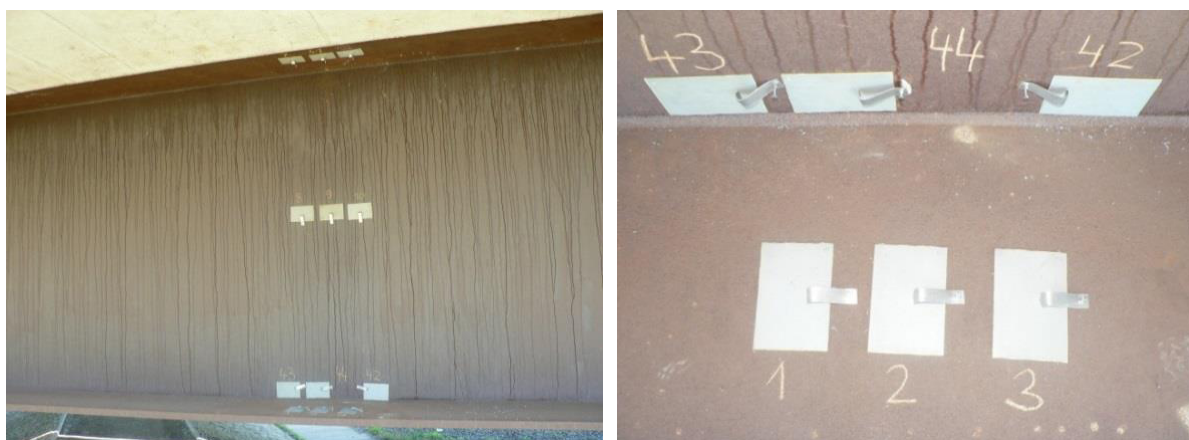
Fig. 1. Installation of corrosion specimens (road bridge over the river Odra on the road II/456 in Ostrava)

realistic behaviour of the investigated structural element surface, see Fig. 1. Standard specimens used for atmospheric corrosion tests according to ISO 9226 [2] (test panels 100x150 mm with thickness of 1.5 mm) were chosen for this experimental testing. The specimens were made of sheets (steel grade S355J2WP) commonly used for building facades [3]. The backside of the specimens, i.e. the side adjacent to the steel structure, is masked to evaluate the corrosion attack only on the exposed side of the specimen.

Corrosion specimens are attached to the steel structure using a simple anchoring device made of stainless steel. This attachment method provides tight contact between corrosion specimen and examined surface of the steel structure. The contact area between the pressure element and the corrosion specimen is minimal, so there is no influence in the development of corrosion products on the exposed surface and specimens copy the thermal inertia of structural elements. Three corrosion specimens have been installed on each of the examined surfaces. Before the installation, the thickness of corrosion products had been measured on all investigated surfaces. Portable thickness gauge based on magnetic induction is typically used for the measurement of rust layers thickness. The planned duration of the experimental atmospheric testing is 10 years. The thickness of corrosion products on surface of specimens is measured at yearly intervals. Sampling of corrosion specimens for determination of corrosion losses is planned at 1, 3 and 10 years of exposure (only the corrosion data after one year exposure of specimens are available nowadays).

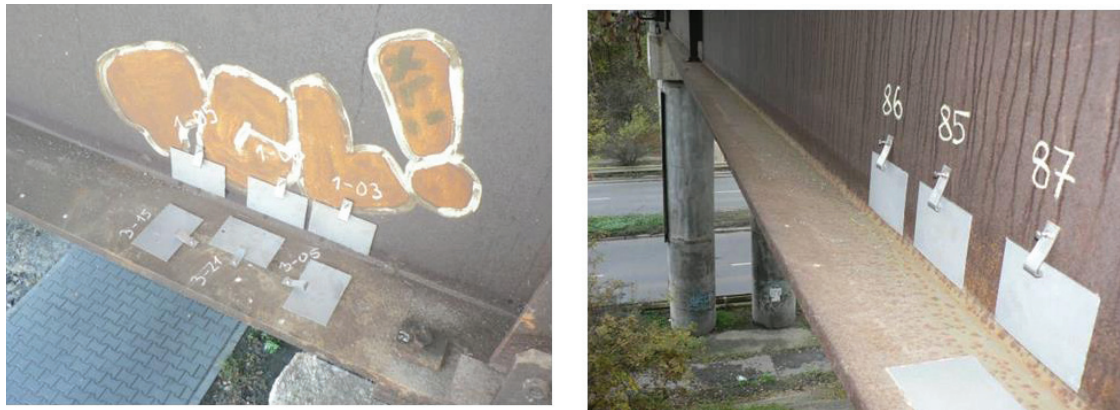
Fig. 2. Visually different strip of corrosion products on the outer web of main girder close to the bottom flange.

Visually different (darker) strip of corrosion products is usually created on outer webs close to the bottom flanges, see Fig. 2. This phenomenon occurs only on the outer webs and is caused by different type of wetting in contrast to usual web surfaces of the main girders. On the adjacent bottom flange remains more moisture, deposition, dirt and in winter also snow. The average thicknesses of corrosion products measured on outer webs close to the bottom flanges are 1.31 times higher compared to typical surface of the web (coefficient of variation of the ratio $V_x = 0.19$; quantile 5% $x_{0.05} = 0.77$; quantile 95% $x_{0.95} = 1.84$).

Increased thicknesses of corrosion products were detected on external webs of main girders close to the bottom flanges. This effect is caused by higher wetting in contrast to typical web surfaces. However, the increase of corrosion thicknesses is not extensive and the protective ability of rust layer is still sufficient. Differences between external and internal webs of main girders are very small.
